✓
AFML-TR-72-30

INSTALLATION OF A SELF-SEALING MATERIALS
SYSTEM IN A C-130 INTEGRAL FUEL TANK WING

Northrop Corporation
Aircraft Division

September 1972

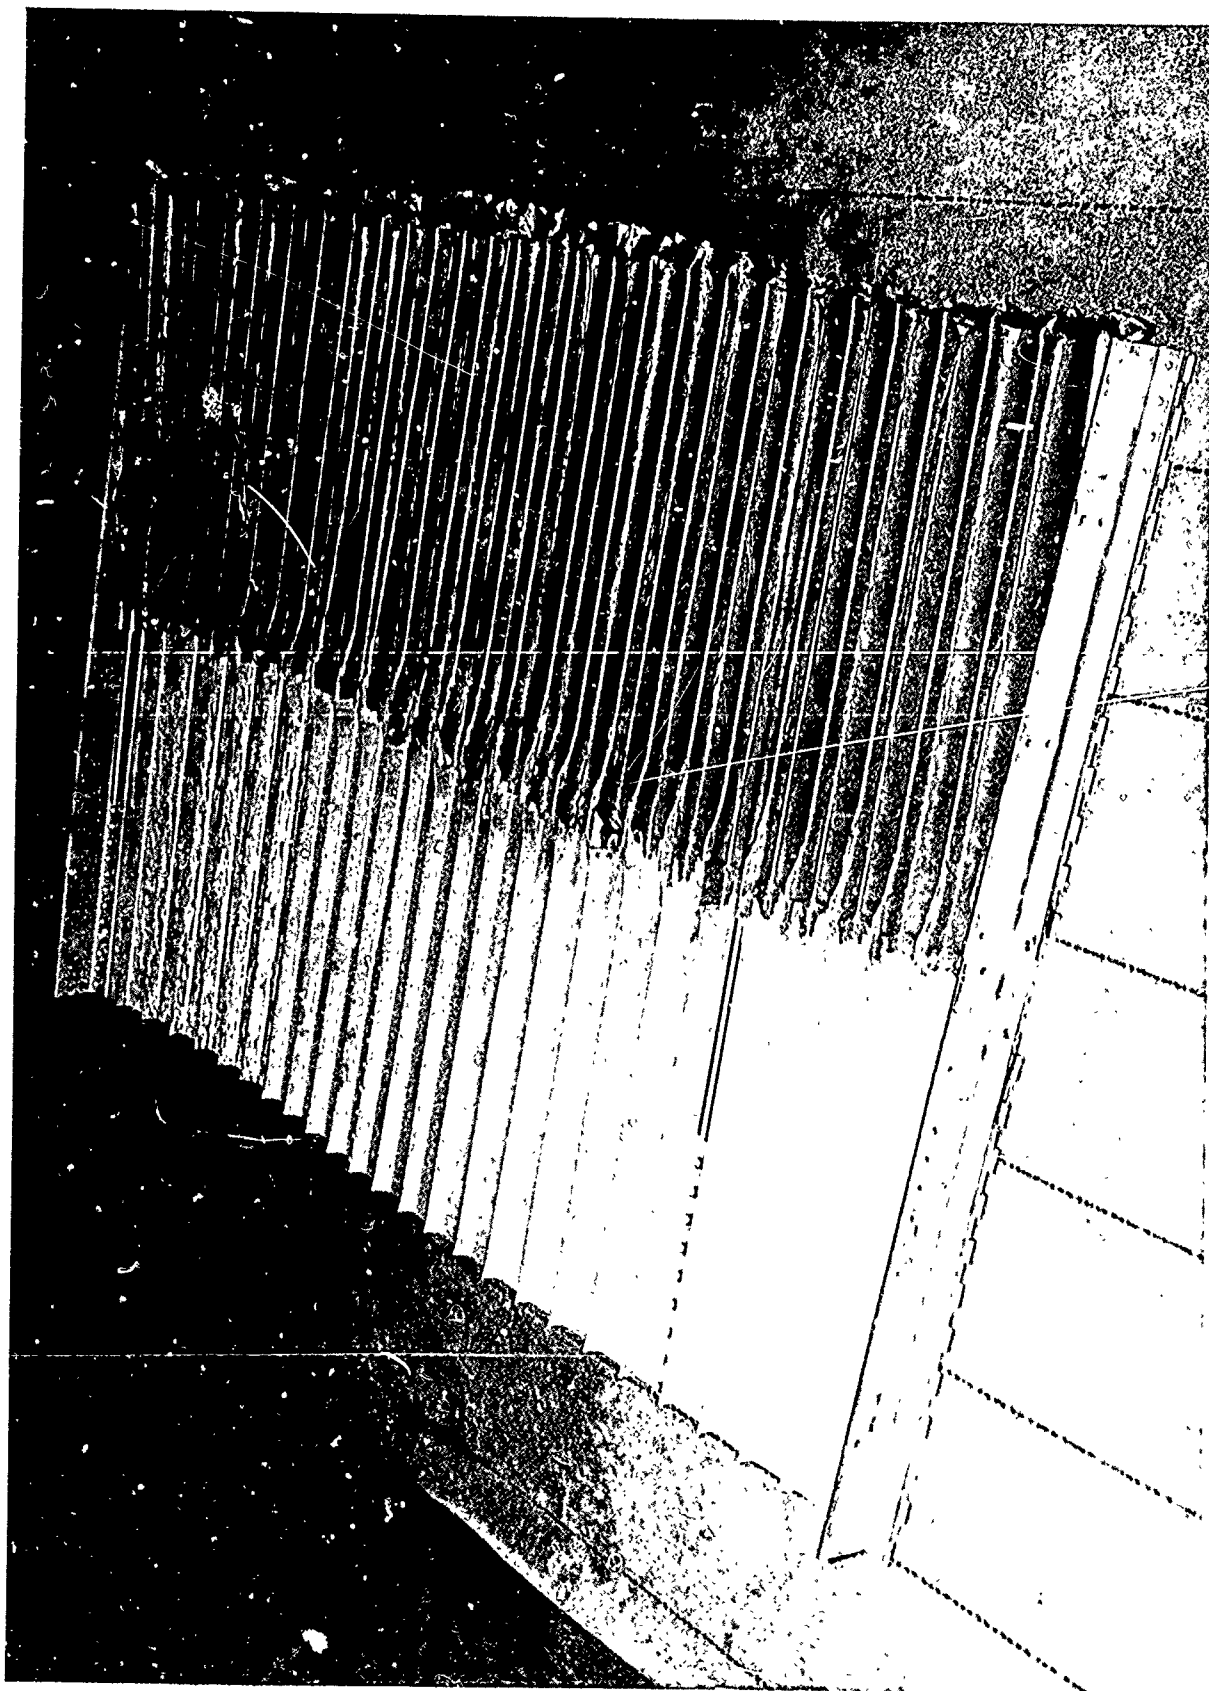
FIGURE 17. C-130 WING SKIN SECTION USED AS A MOLD

A method for fabricating the flexible corrugated ballistic nylon laminates was developed. In the method which showed most promise, the laminate was prefabricated using a C-130 wing skin section as a mold. The mold, which was used for the fabrication of the corrugated flexible laminates to be installed in the slosh and vibration test tank, was obtained by dismantling the bottom C-130 skin structure of the wing station OWS 456 to OWS 491. Figure 17 shows this particular mold. Using this mold, the following materials, equipment, and procedure were used for the fabrication of four-ply corrugated laminates.

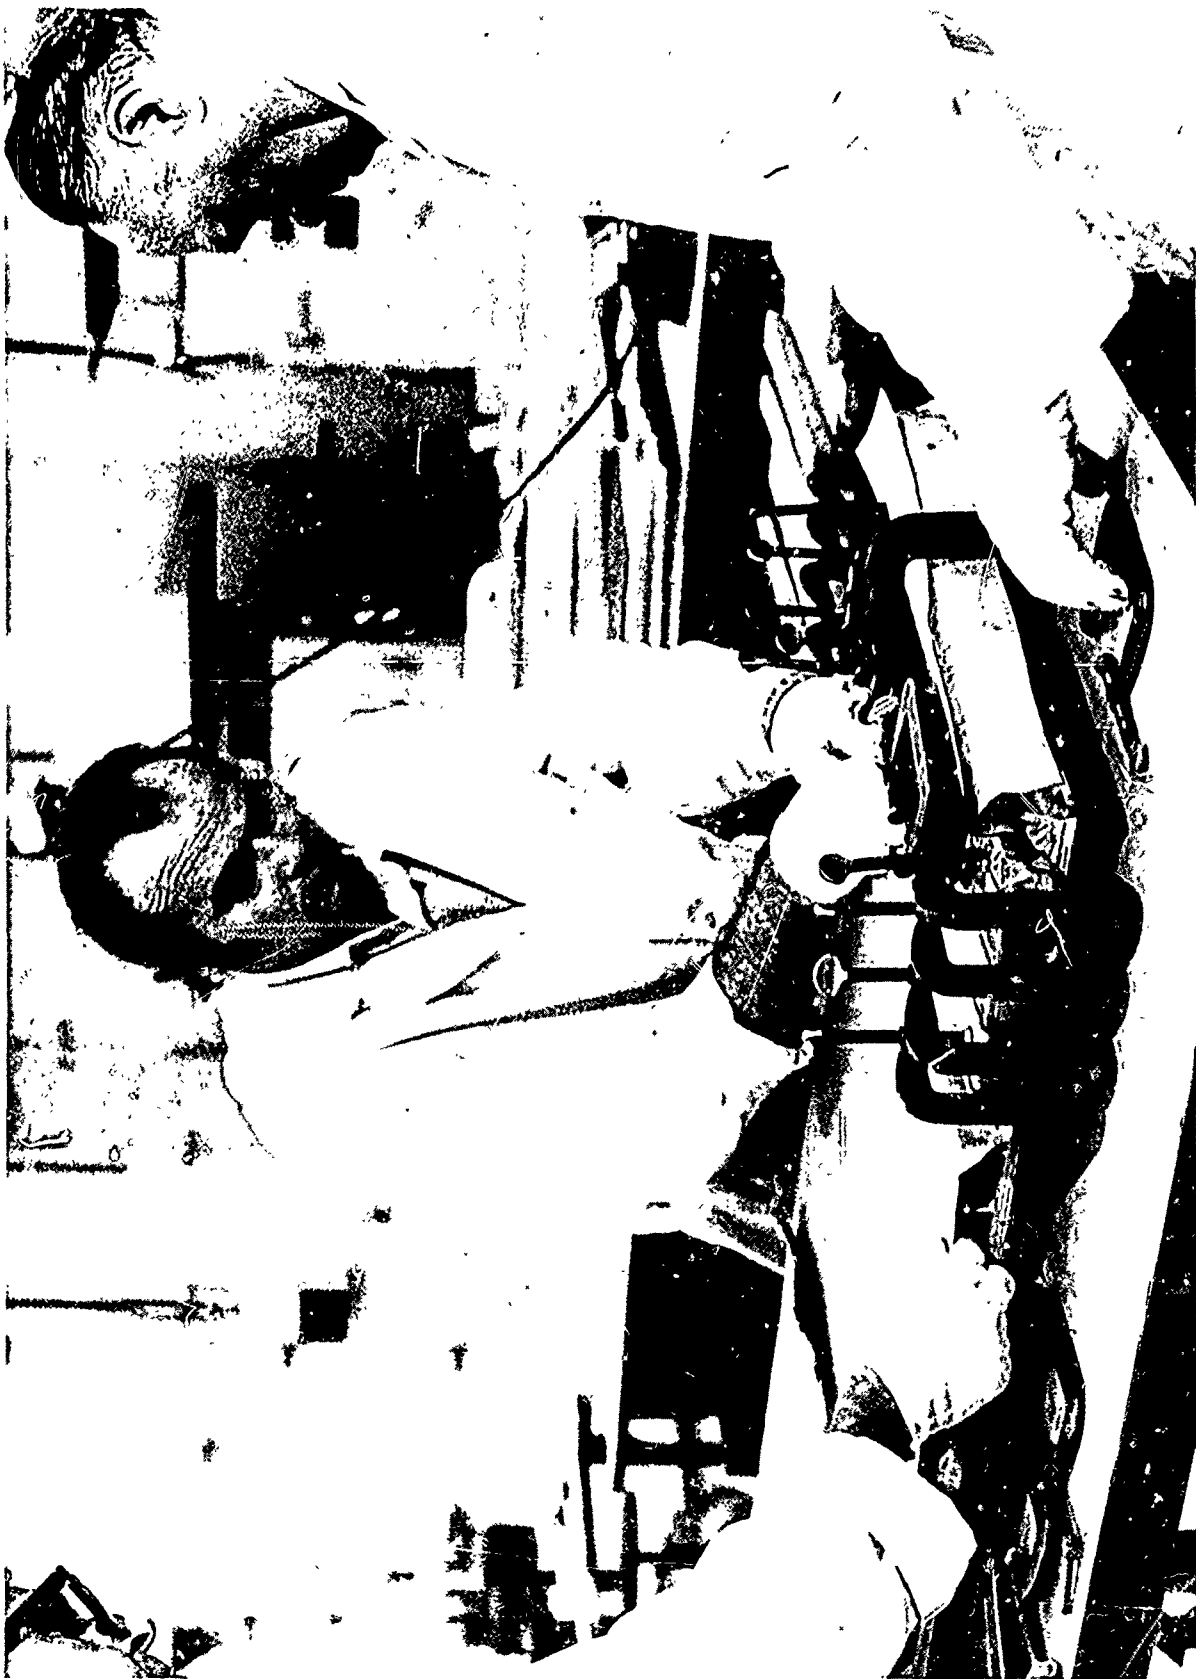
FIGURE 20. FITTING THE WET BALLISTIC NYLON LAMINATE TO THE MOLD -
A CLAMPING SYSTEM IS USED FOR OBTAINING A BETTER
QUALITY LAMINATE

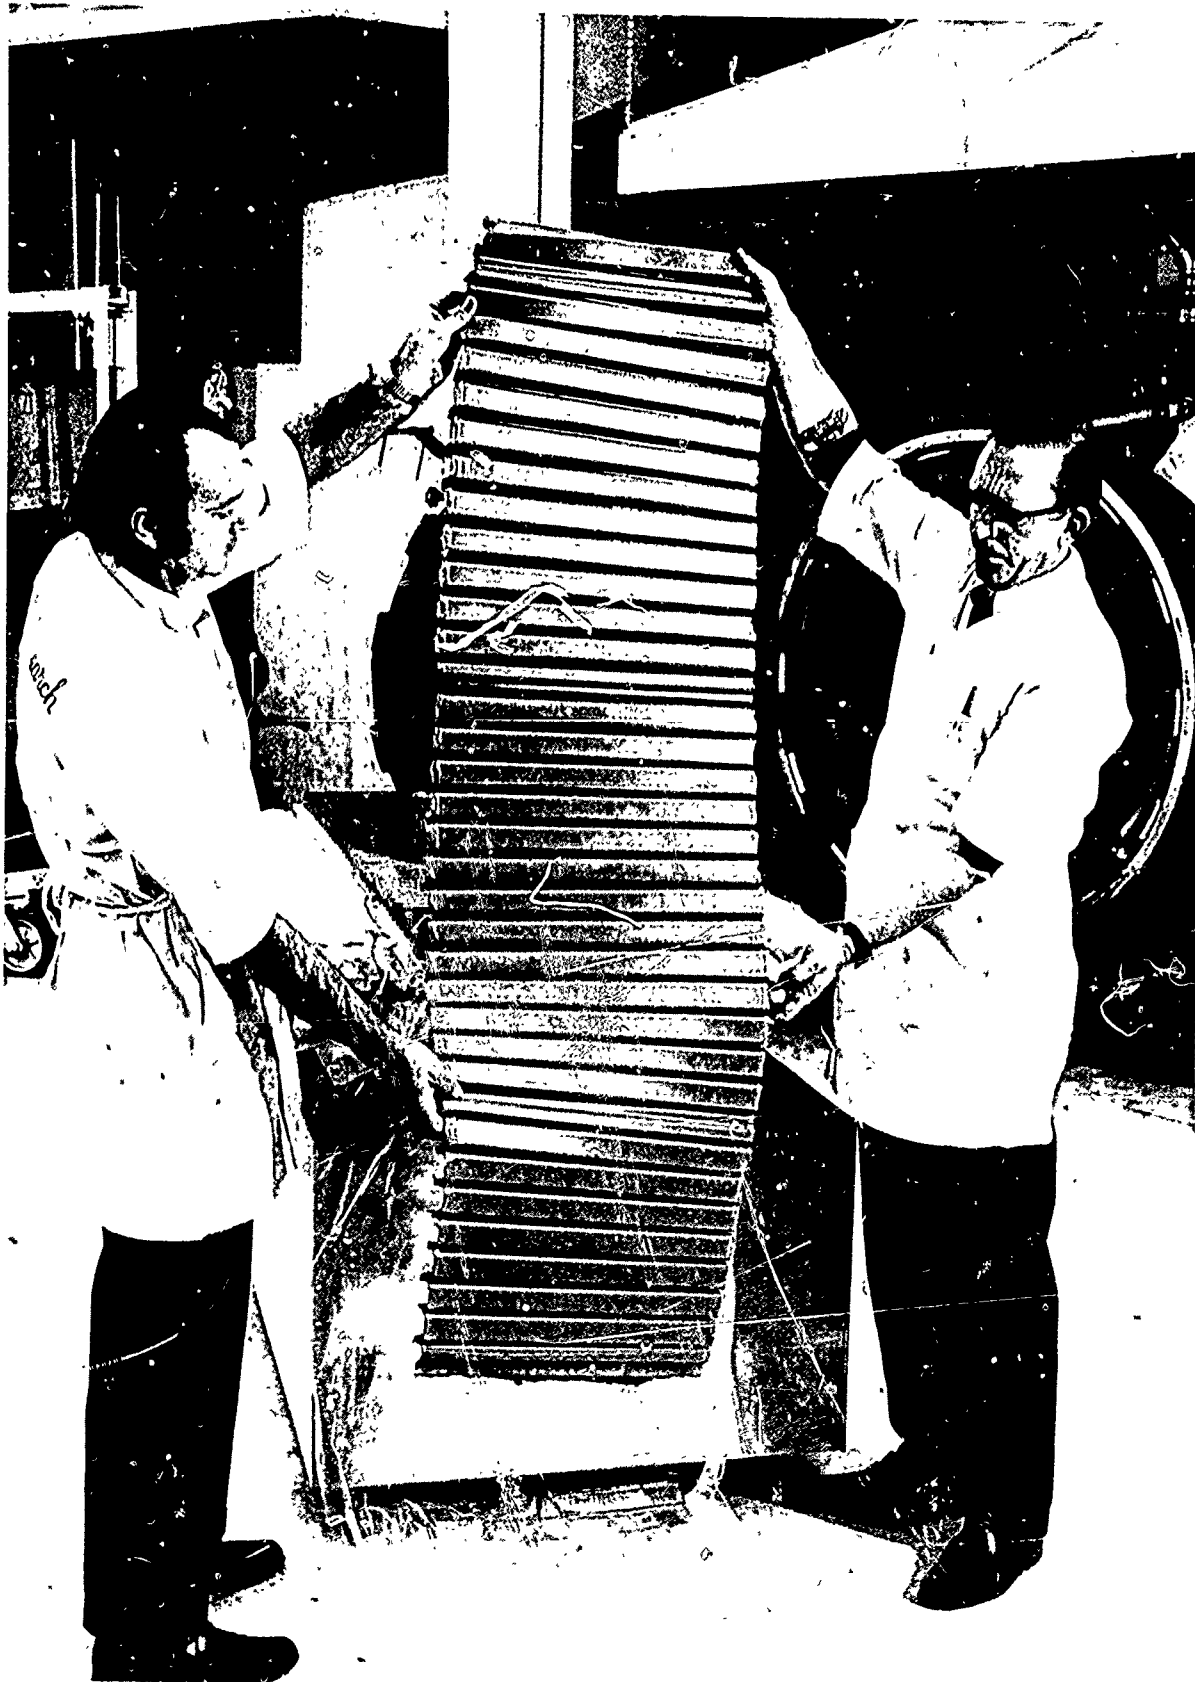
FIGURE 22. A FINISHED CORRUGATED LAMINATE IS SHOWN

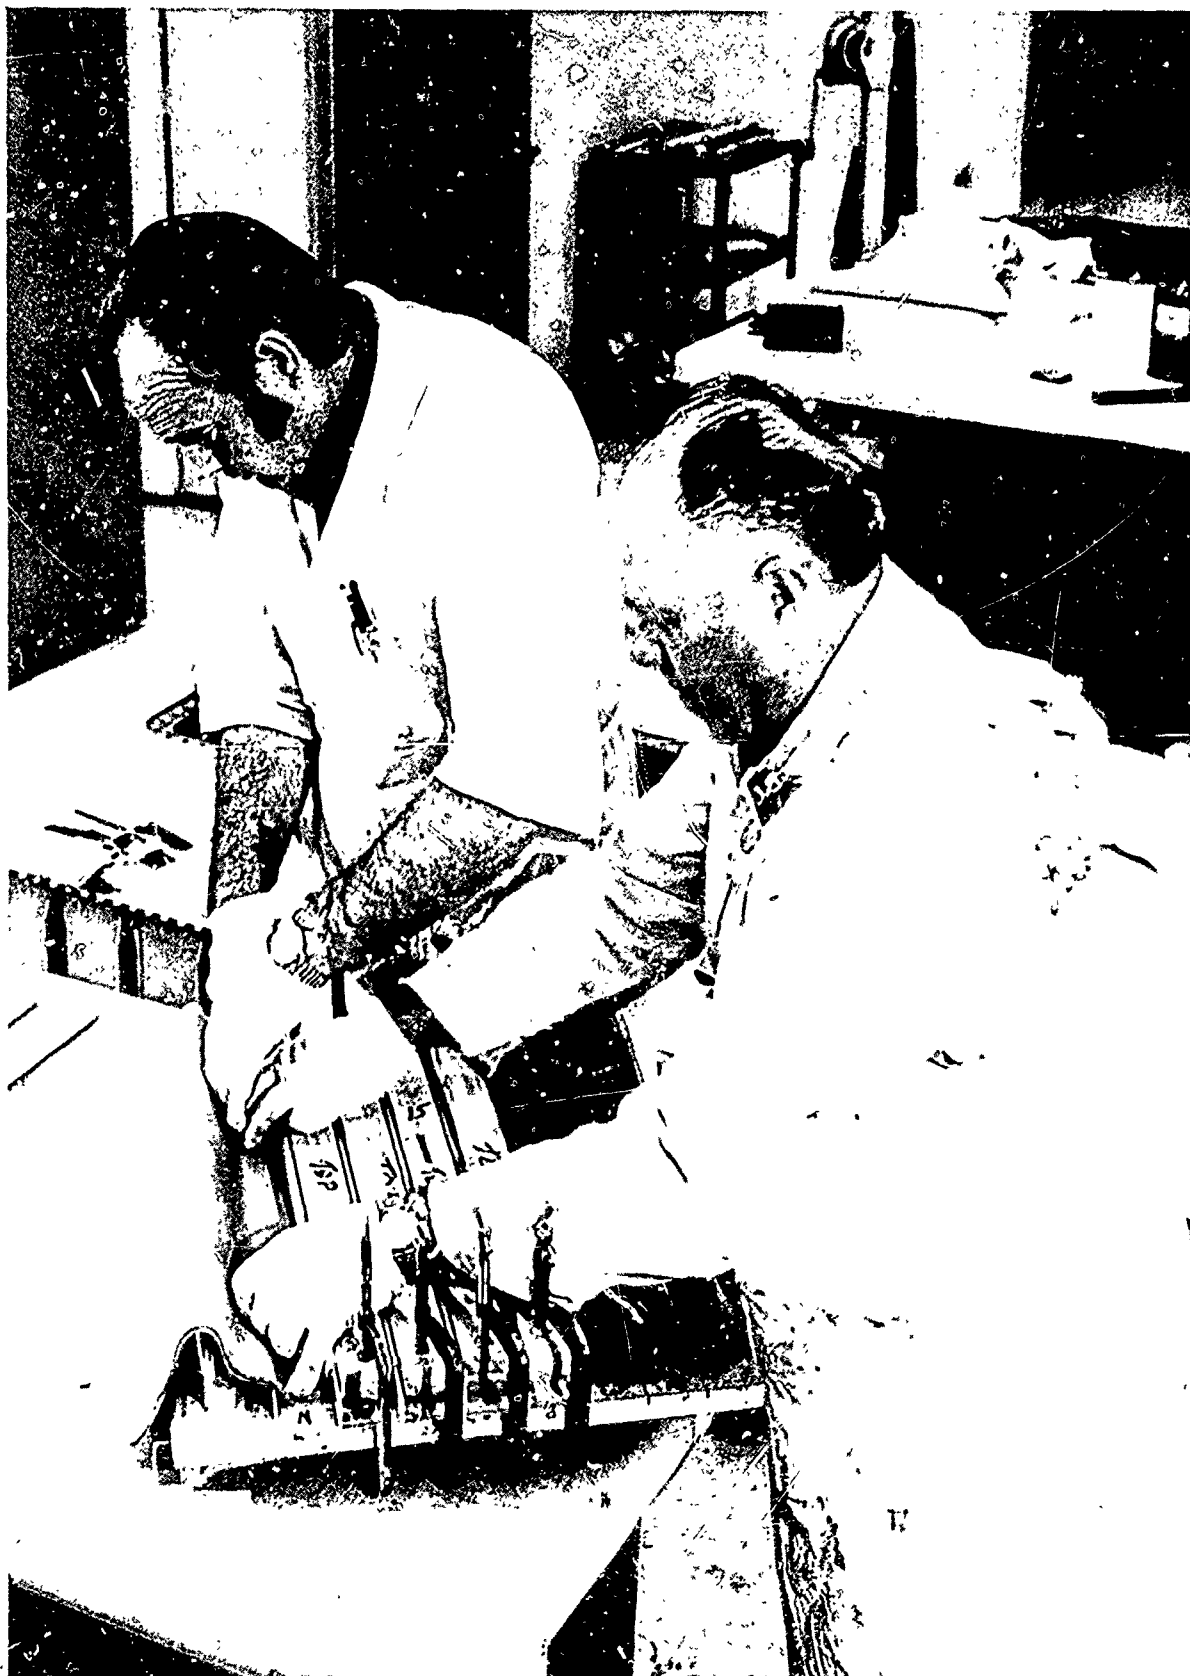
FIGURE 23. MOLD USED FOR THE ASYMMETRICAL SECTIONS
OF THE TANK BAYS

are symmetrical or alike. However, on the tapered side, the corners, from one bay to the next, are not alike; they are asymmetric. For fabricating the corrugated laminates to be installed in these asymmetrical corner-sections, a special mold had to be fabricated for each bay of the two tanks. An example of such a special mold is illustrated in Figure 23. The procedure for fabricating the corrugated laminates, using these special molds, was similar to the one described above. Figure 24 shows one of the completed corner-section laminates usable only for the corner of one specific bay of the tanks. Ten different molds were fabricated for preparing three corner laminates for the slosh and vibration test tank and seven for the firing test tank.

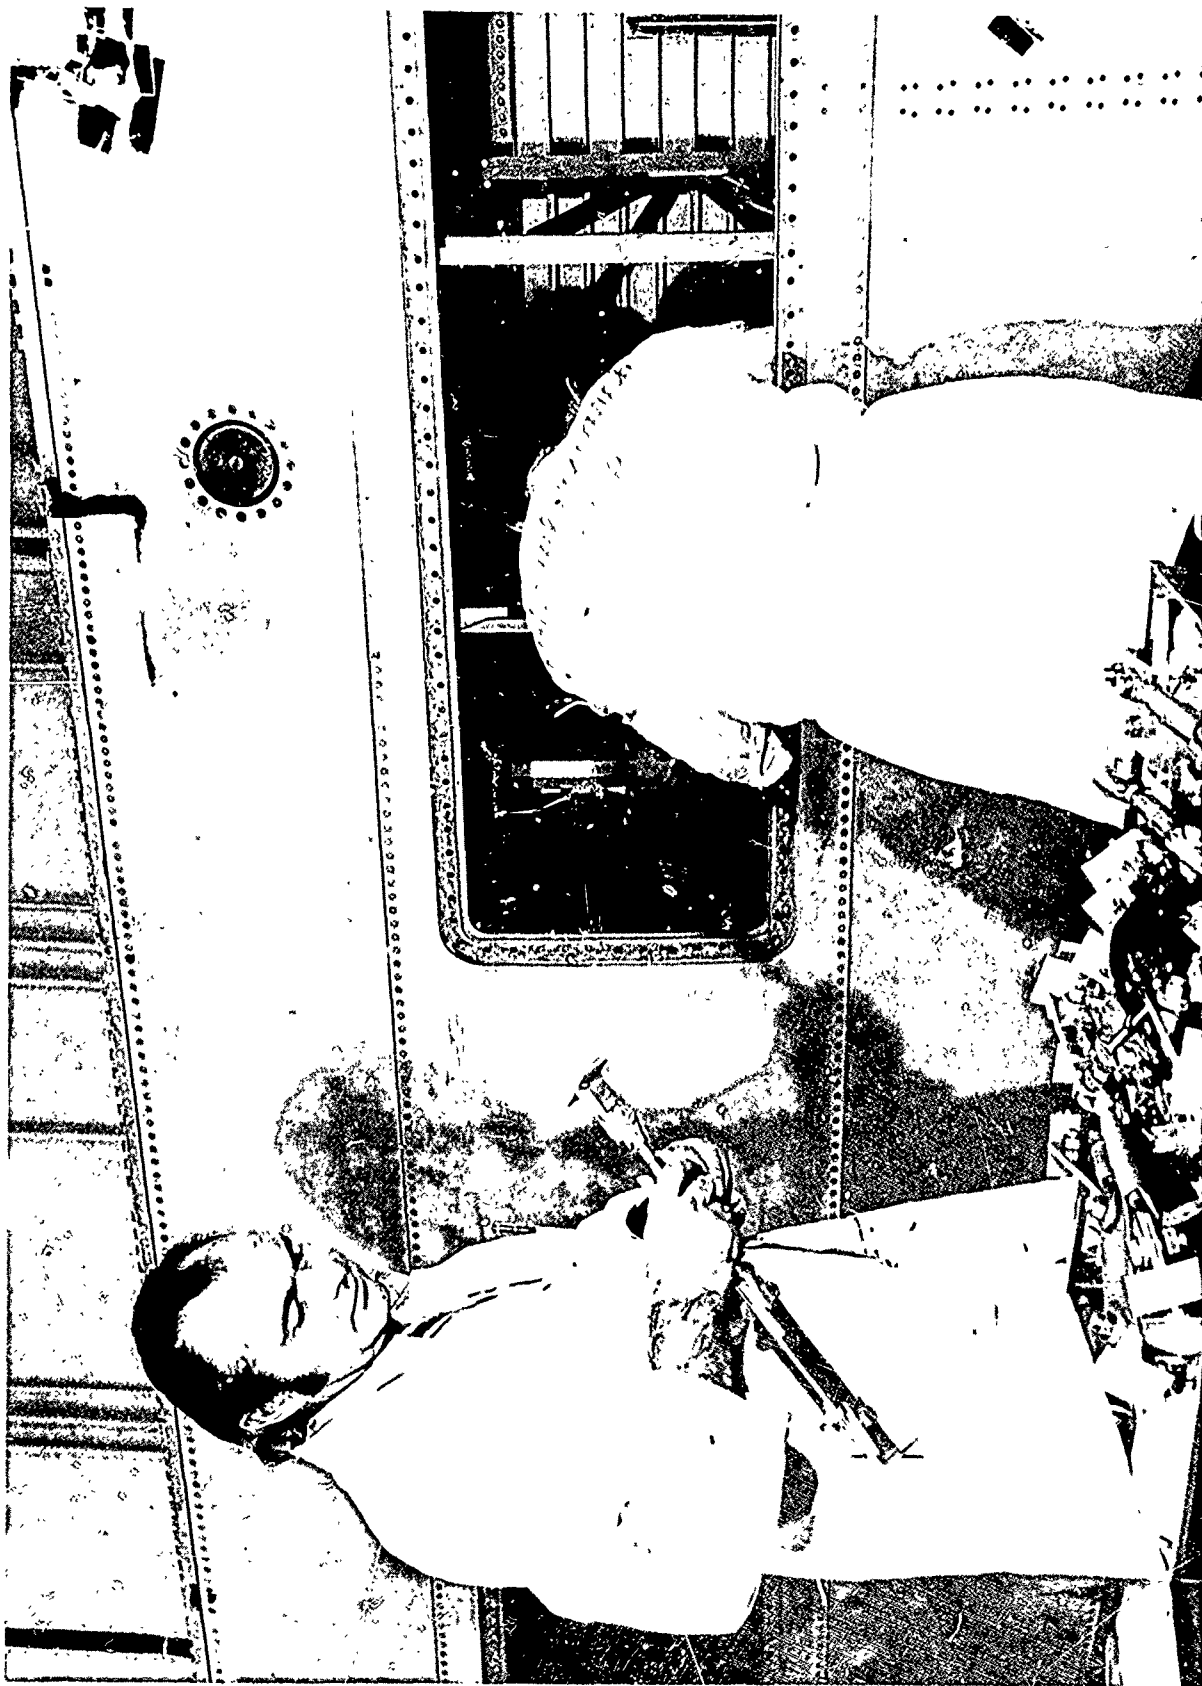
FIGURE 25. INSTALLATION OF THE CORRUGATED LAMINATE USING
TURN-BARRELS FOR PRESSURE APPLICATIONS

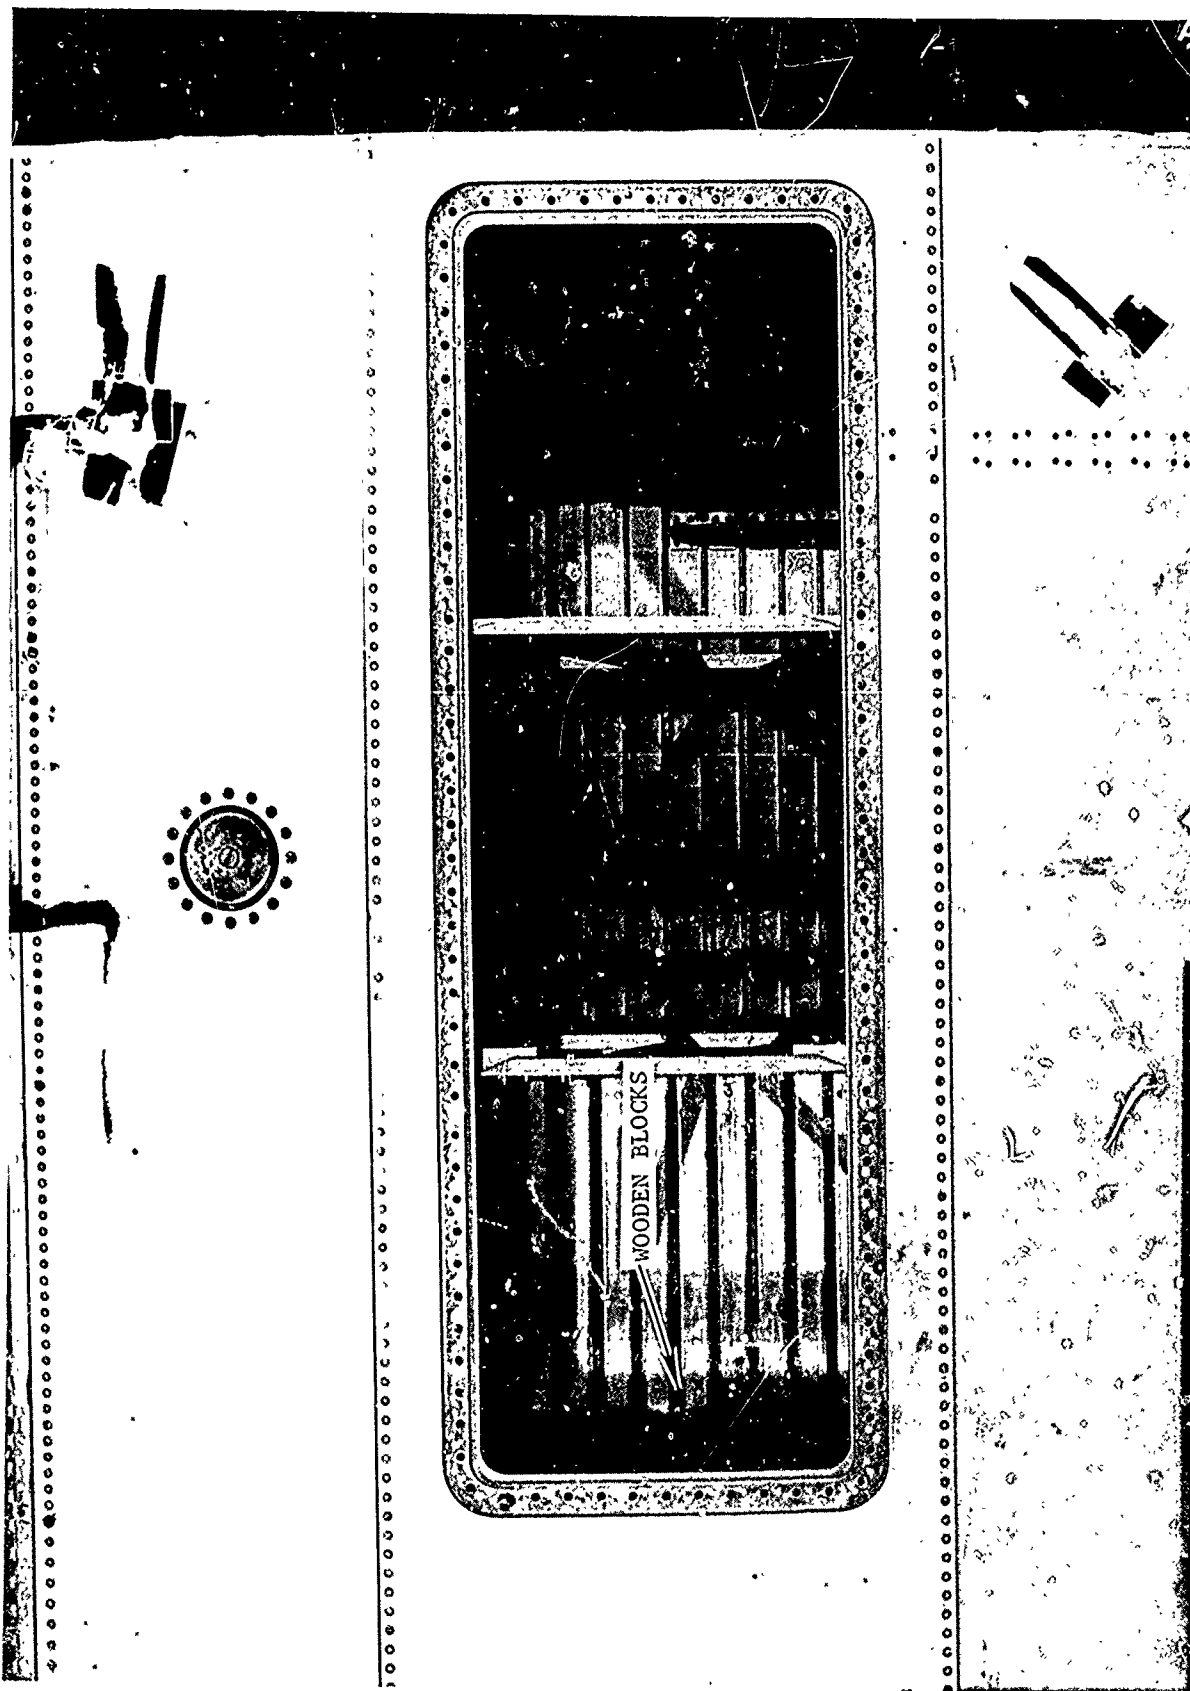
FIGURE 27. SPECIAL WOODEN BLOCKS INSERTED BETWEEN THE RIBS

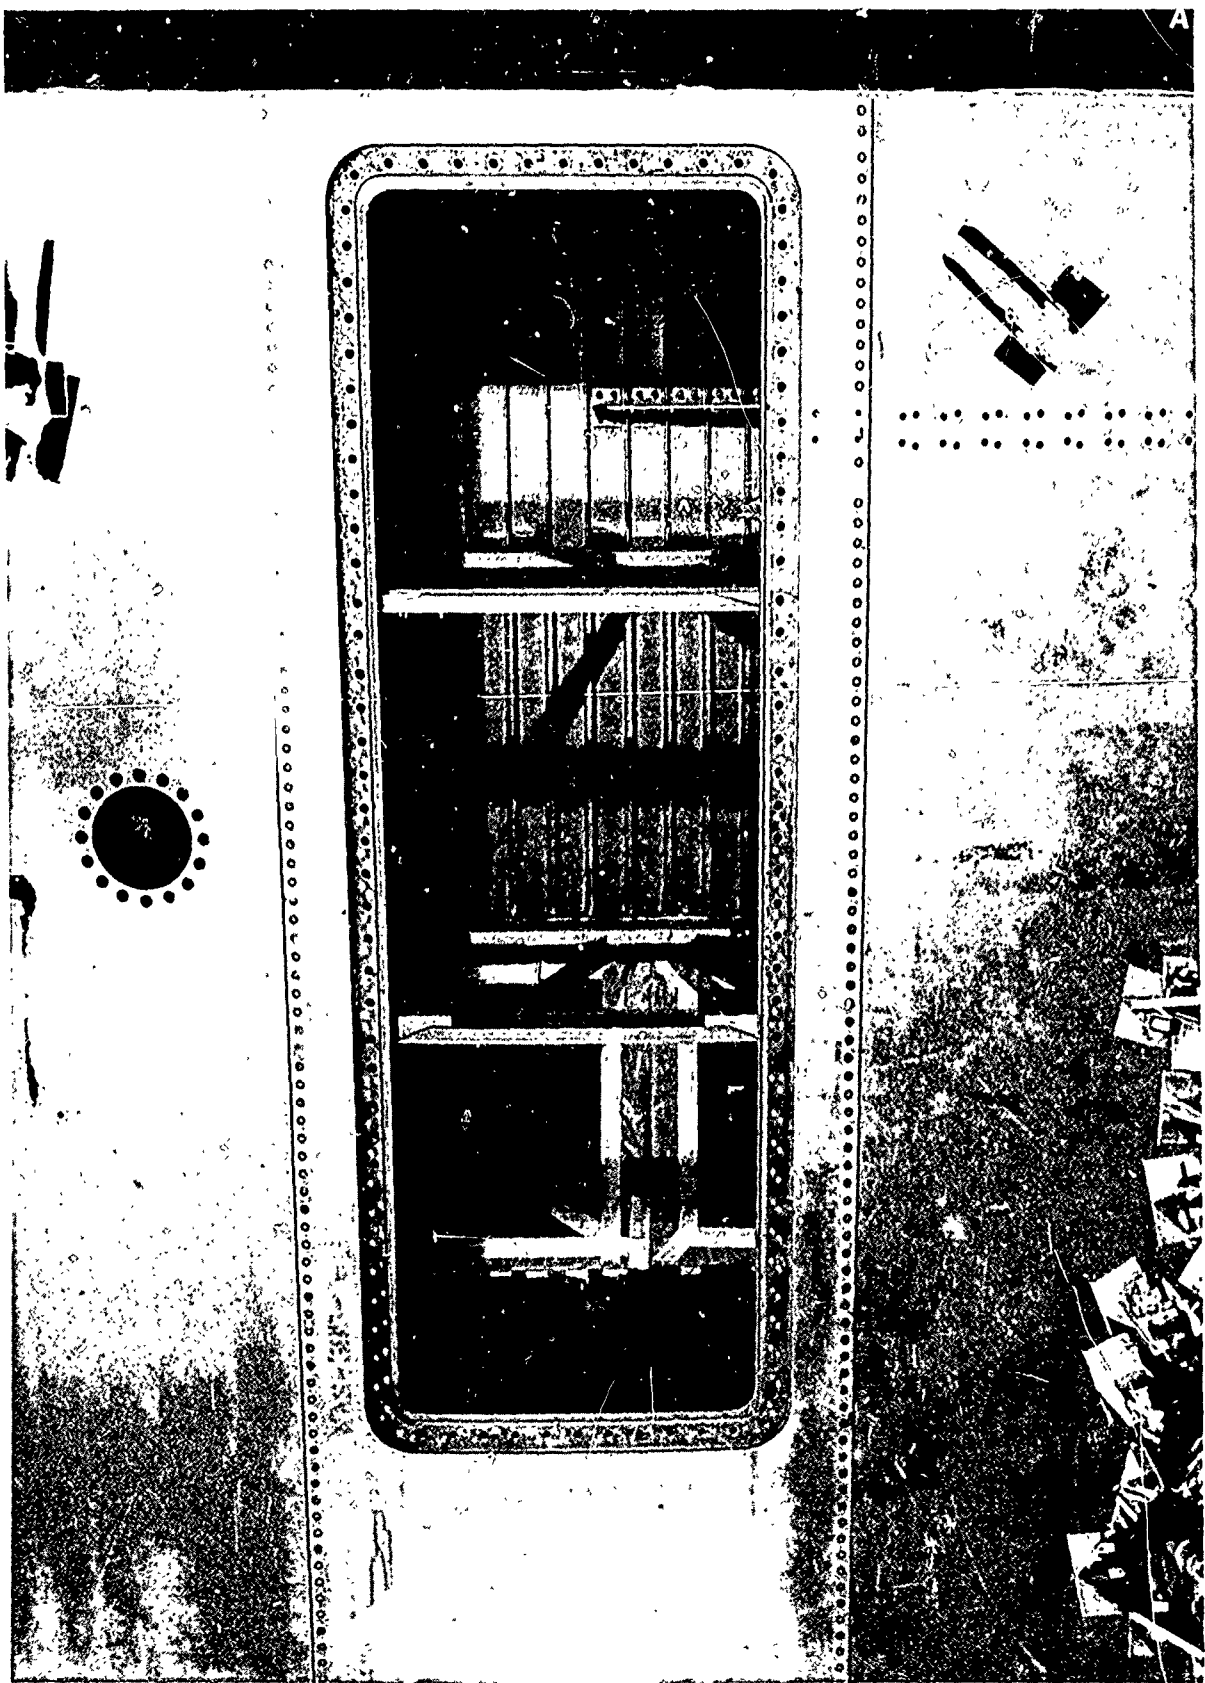
FIGURE 28. LARGE METAL PLATES USED TO OBTAIN A MORE UNIFORM PRESSURE

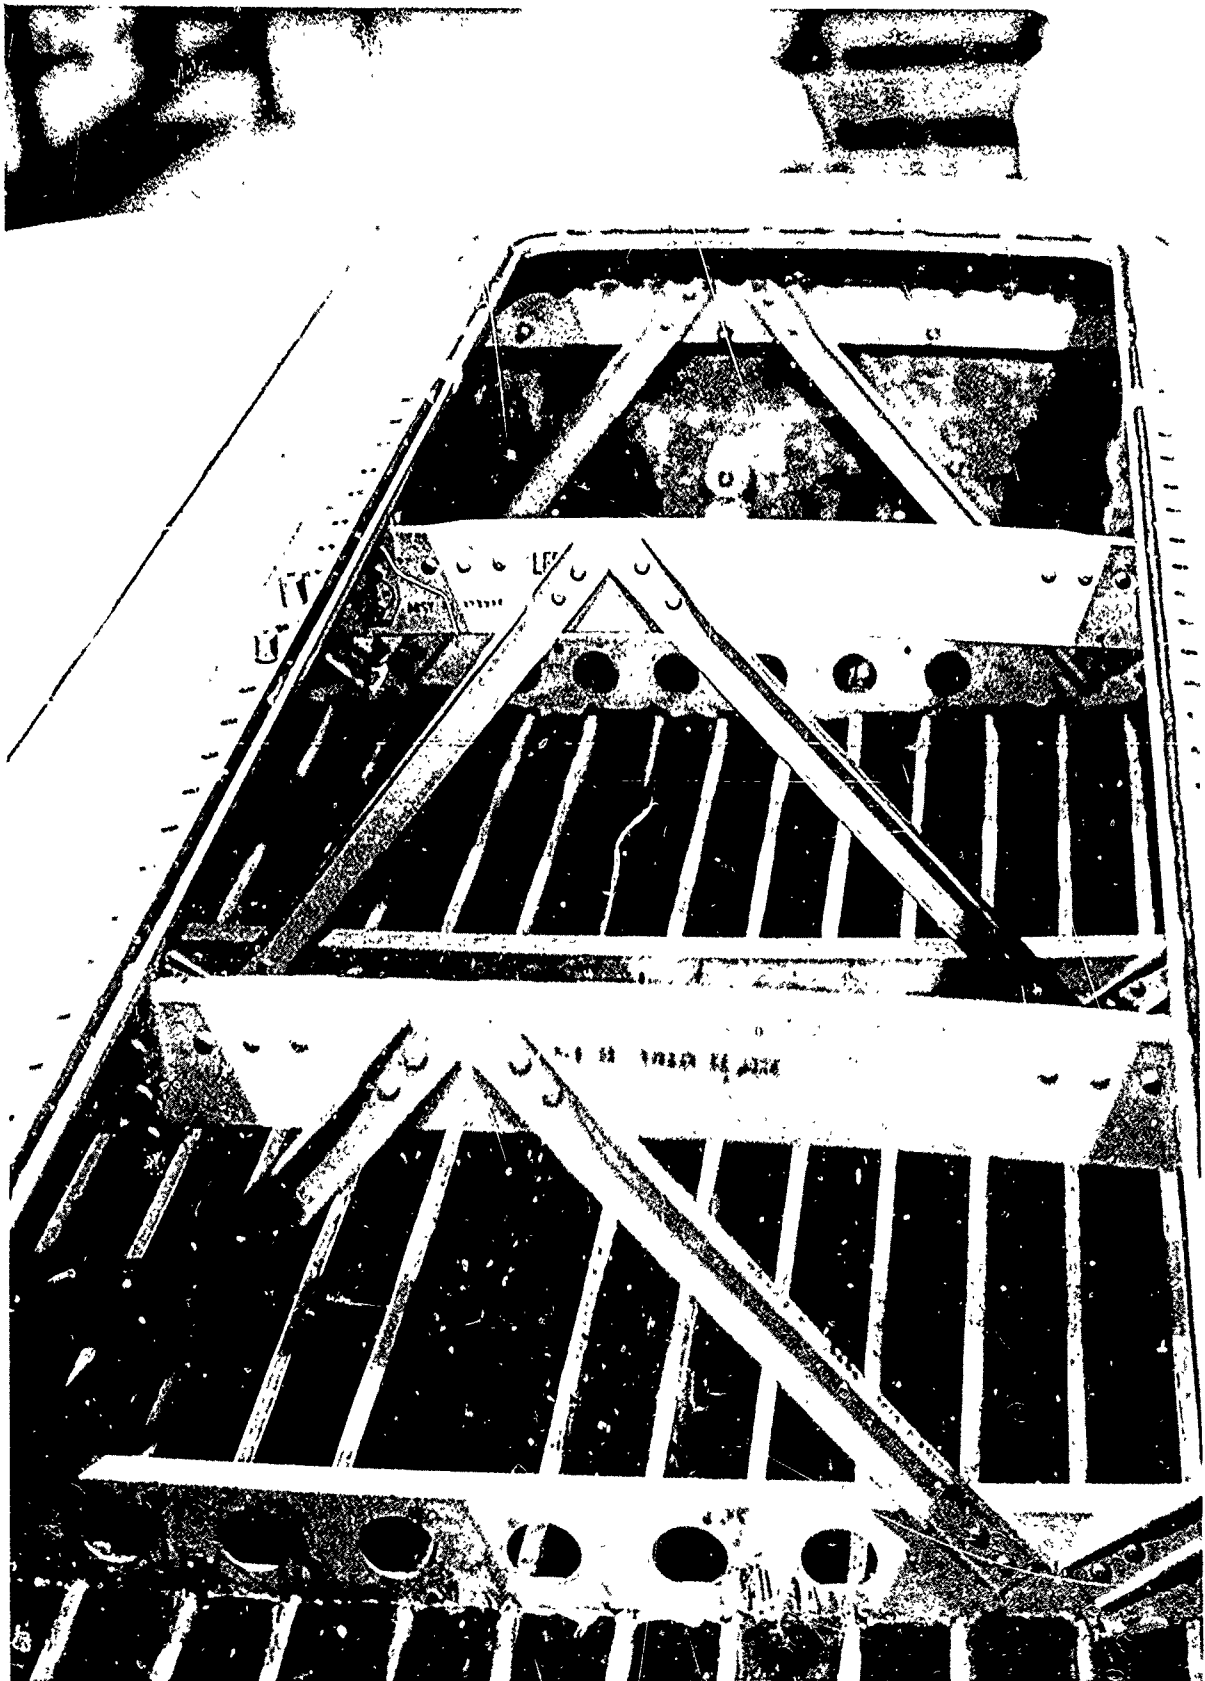
FIGURE 31. TANK BAYS WITH PRECOMPRESSED FOAM INSTALLED

For the installation of the foam in the slosh and vibration test tank, strips of foam 1 3/4-inch wide and 5/8-inch high were cut. At the bottom part of the tank, the rib spacing was 1 1/2 inch and the height of the ribs 5/8-inch. After installation of the foam strips, the degree of precompression of the foam was approximately 15%. In the actual installation, the foam was squeezed in between the ribs and bonded on all three sides and at the ends with 898 sealant as shown in Figure 30. A uniform pressure was applied by means of metal plates and turn barrels. The curing of the sealant was performed in a large oven at 180°F for 1 1/2 hours. Figure 31 shows the precompressed foam installed in all three bays of the tank.

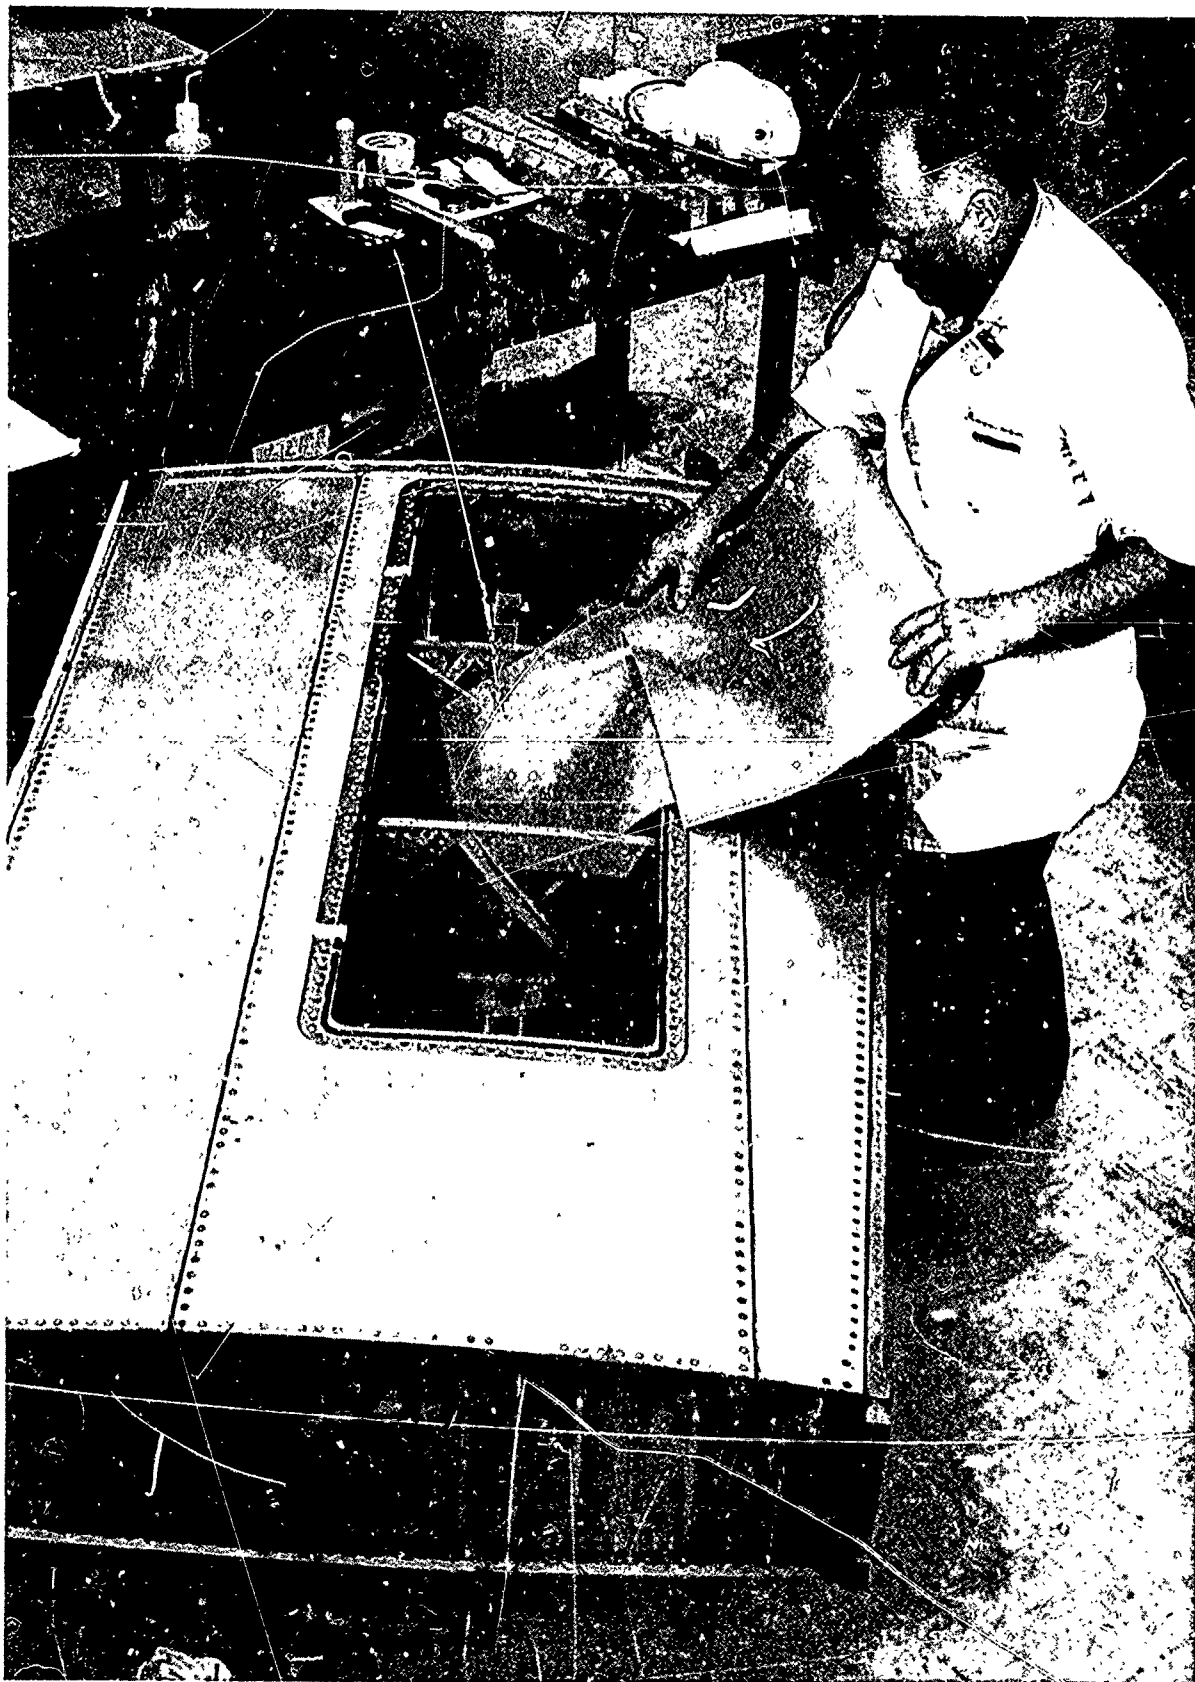
FIGURE 33. INSTALLATION OF A PLAIN LAMINATE IN A TANK BAY

Three of the above fabricated plain flat laminates were cut to fit snugly in each of the three bays. The bonding of the laminates in each bay to the compressed foam and ribs was performed using metal plates and turn barrels to obtain uniform pressure and using 898 sealant as the bonding agent (Figure 33). The curing of the sealant was accomplished by placing the tank in the large oven and heating at 180°F for 1 1/2 hours.

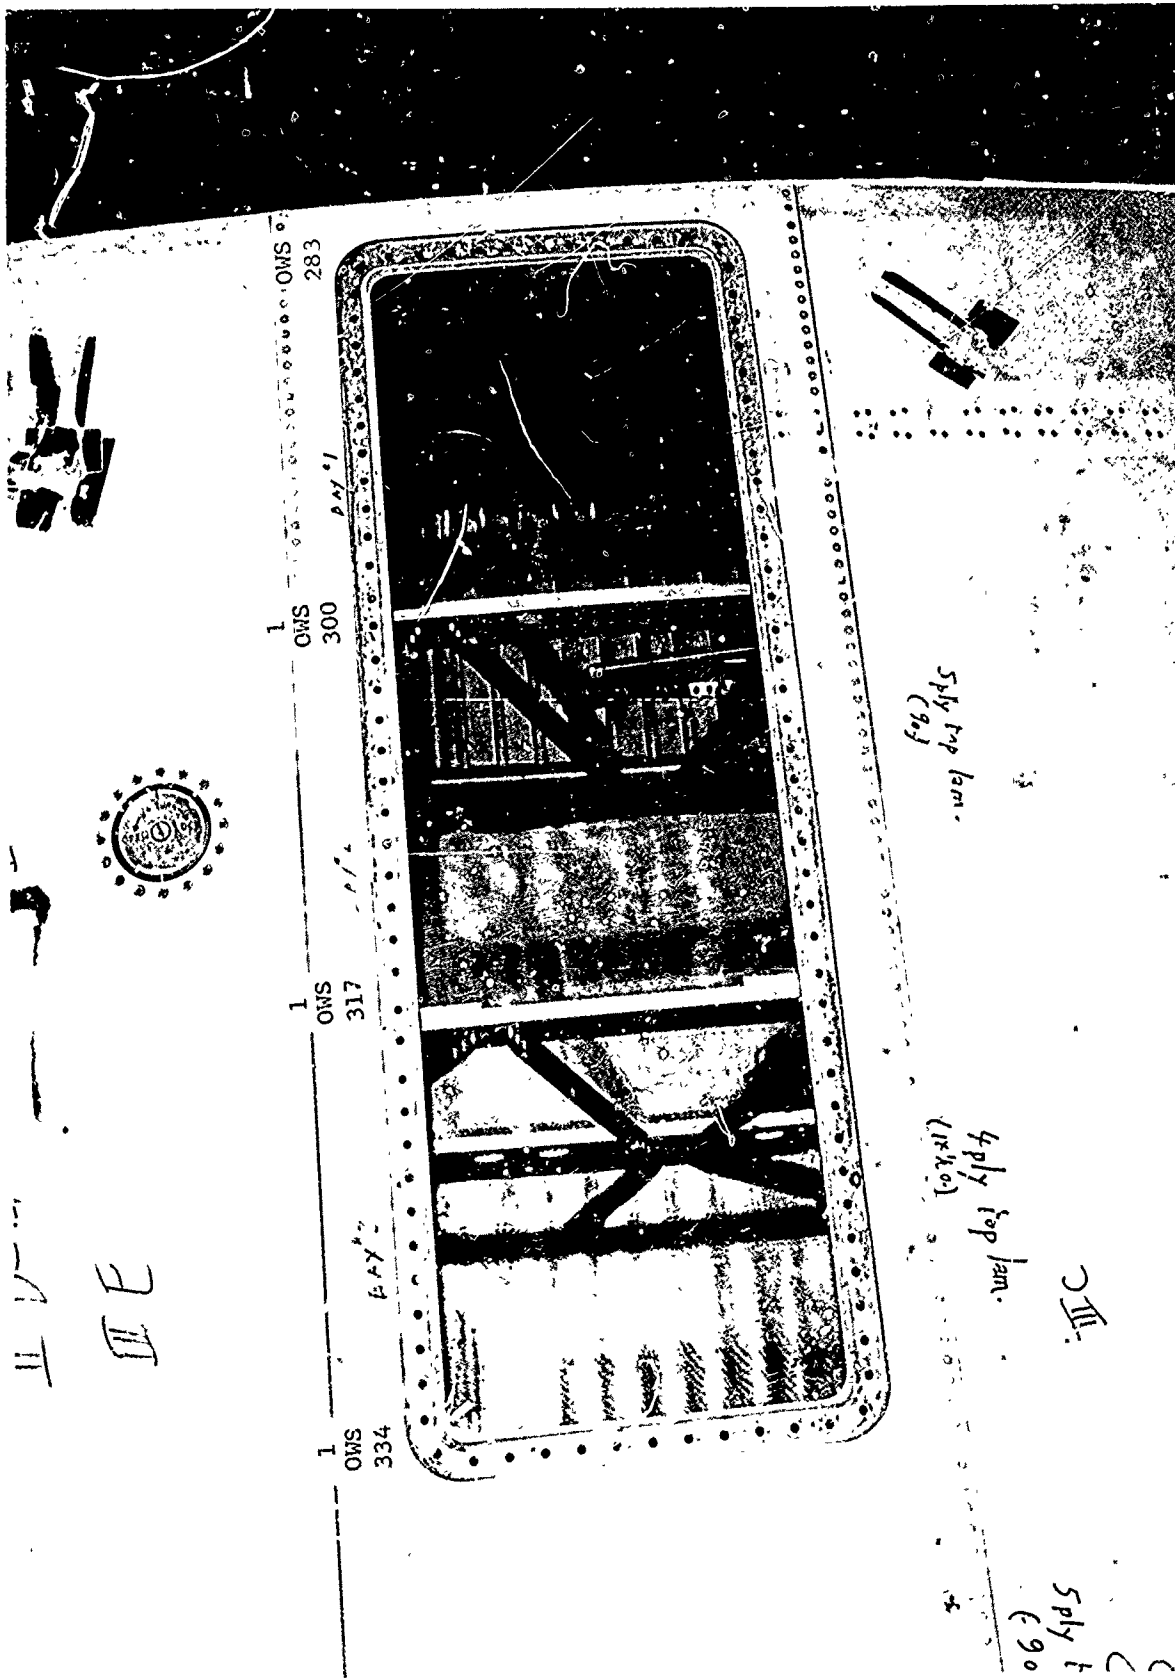
FIGURE 35. CORRUGATE LAMINATE IS INSTALLED IN OWS 283 TO OWS 300 AND SELF-SEALING SYSTEM IS INSTALLED IN OWS 300 THROUGH OWS 334 OF THE FIRING TEST TANK
